CONFIDENTIAL INSPECTION REPORT

XXXX XXXXXXXX
XXXXXX, MI

Inspection Date 3/23/12

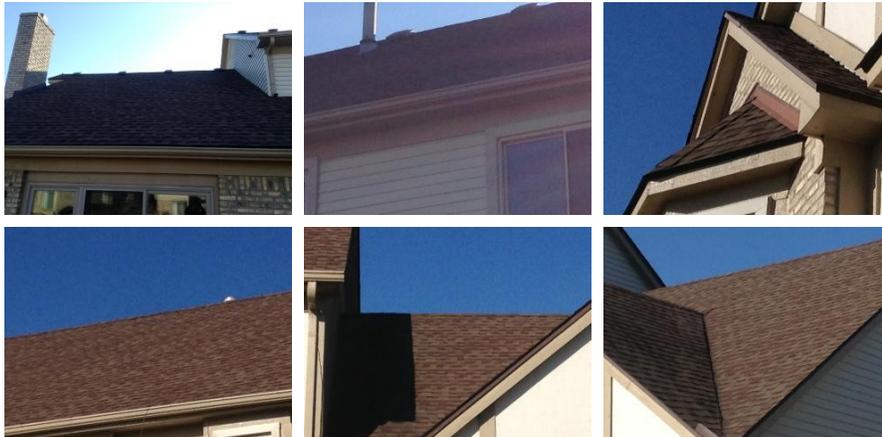
Marginal

Overview: **Some areas will tend to hold snow, ice and water and will be prone to leaks, Monitor and repair as needed**

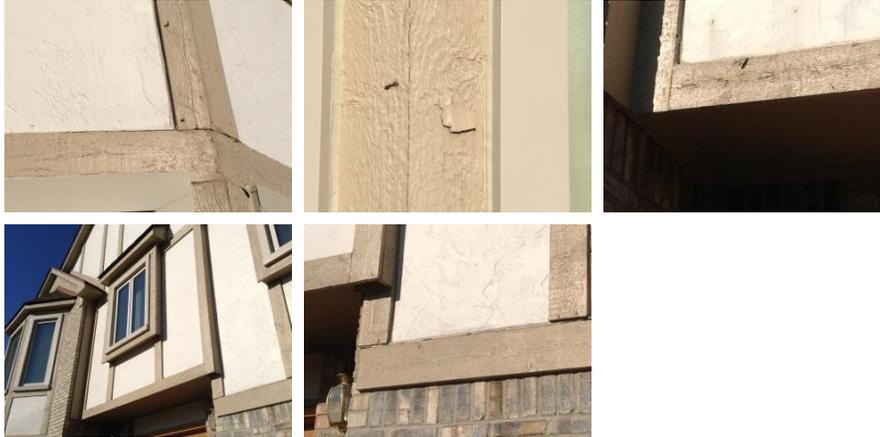
Marginal

Overview: Areas open and vulnerable to water infiltration, Caulking defects, Composite siding has a history of problems expect failures, Rotted wood, Swelled composite siding, Damaged siding, Evidence suggesting poor or neglected maintenance, Peeling paint and bare wood, Monitor and repair or replace as needed

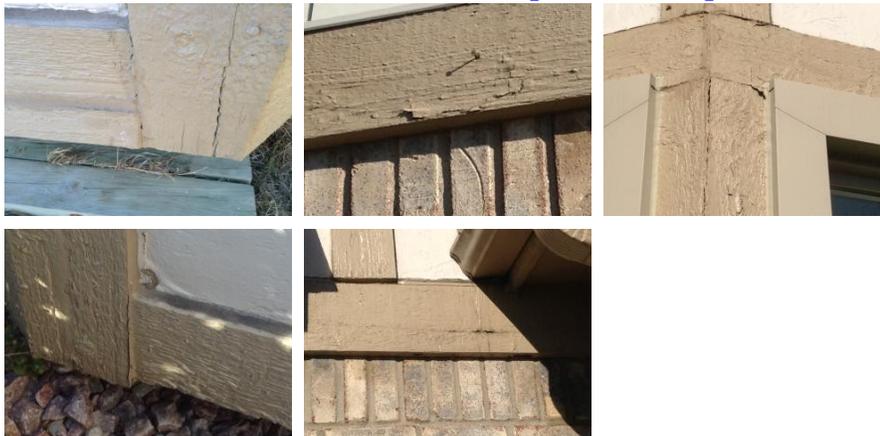
Marginal

Trim: Wood Damaged, Wood rot, Open areas vulnerable to water intrusion, Peeling paint and bare wood, Caulking defects, Checked and weathered wood, Monitor and repair or replace as needed

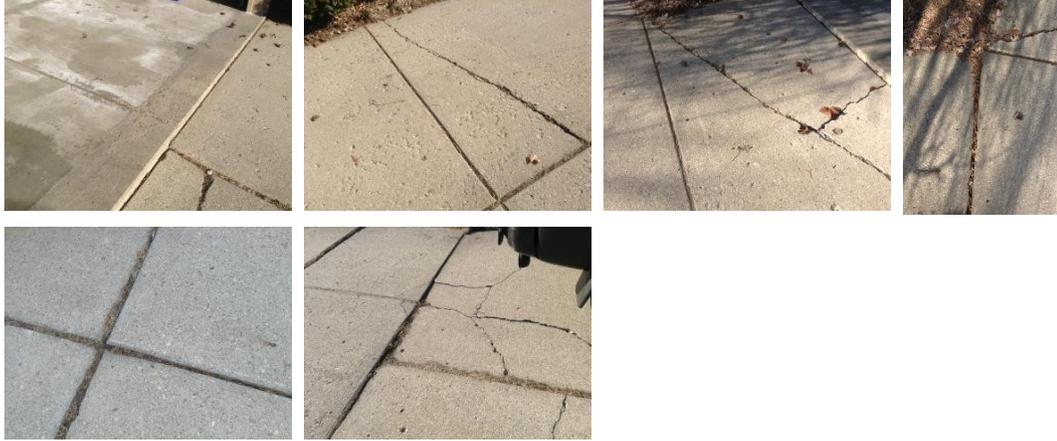
Defective

Driveway: Concrete Heavy cracks in surface, Heaves in concrete causing trip hazard, A qualified contractor is recommended to evaluate and estimate repairs

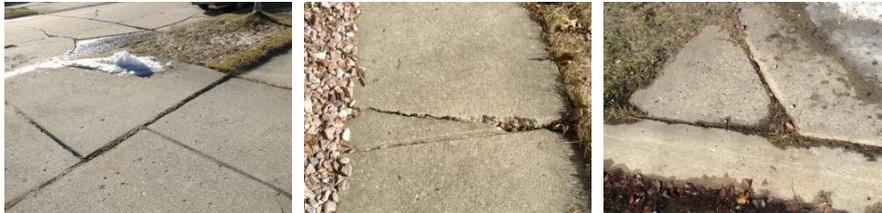
Defective

Walks: Concrete Trip hazard, Heaved, Concrete pitted and chipped, Recommend a qualified contractor to further evaluate for repairs, replacement and cost

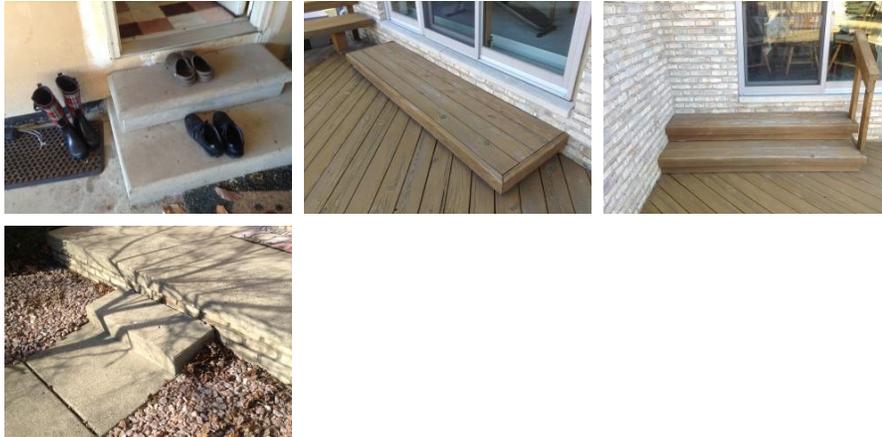
Defective

Steps/Stoops: Concrete, Wood Loose steps, Inconsistent riser is a trip hazard, Weathered and checked wood, Rotted wood steps, A qualified contractor is recommended to evaluate and estimate repairs

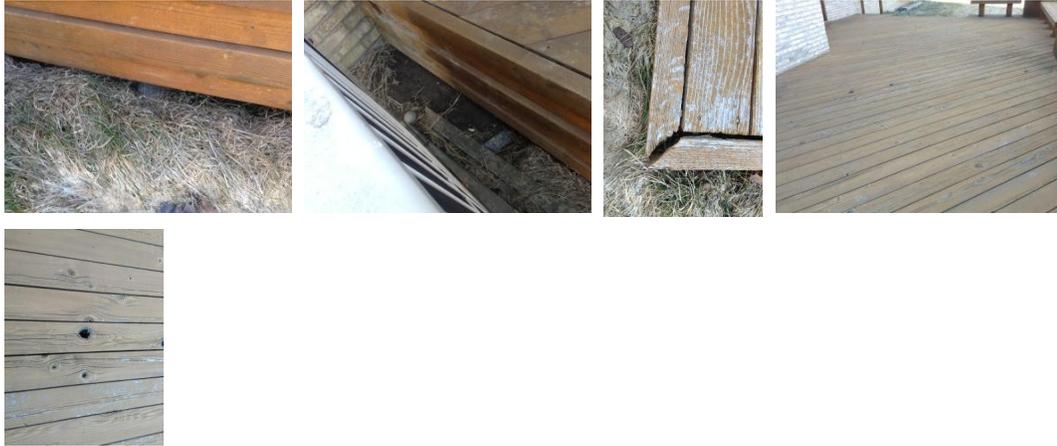
Marginal

Deck(s): Stained wood Peeling stains, Checked and weathered wood, Open to vermin, Monitor and repair or replace as needed

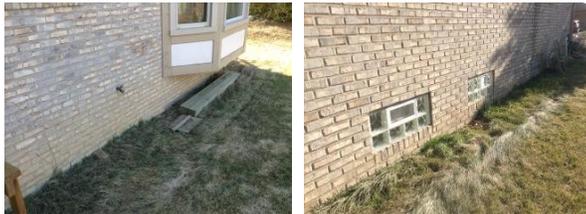
Defective

Grading: Negative slope Improper soil slope towards foundation, recommend the addition of fill dirt to improve grade, Grading has negative slope and water is pooling against the foundation. Expect leaks to the basement due to improper exterior water control, Recommend a qualified contractor further evaluate for repairs, replacement and cost

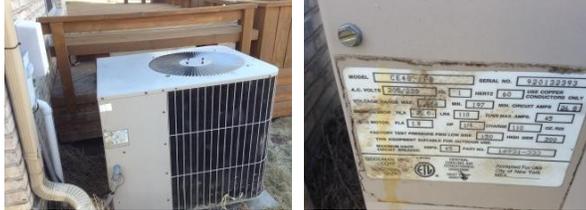
Defective

A/C System Operation: **Not Tested** The unit is currently in service beyond the manufactures stated design life, To avoid possible compressor damage due to outside temperature below 60 degrees, the unit was not tested. Compressor not level, Expect to replace unit in the near future, Have further evaluated by a qualified contractor for repair or replacement costs

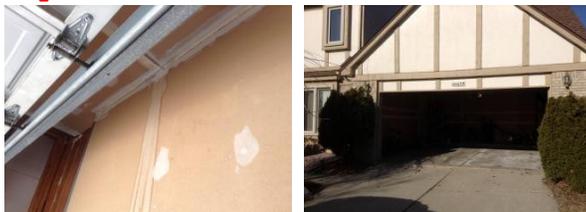
Defective

Overview: **Exterior same as home, Water stained and damaged areas noted suggesting past leaks, Door opener not reversing when resistance is met, Have a qualified contractor further evaluate for repair, replacement and cost**

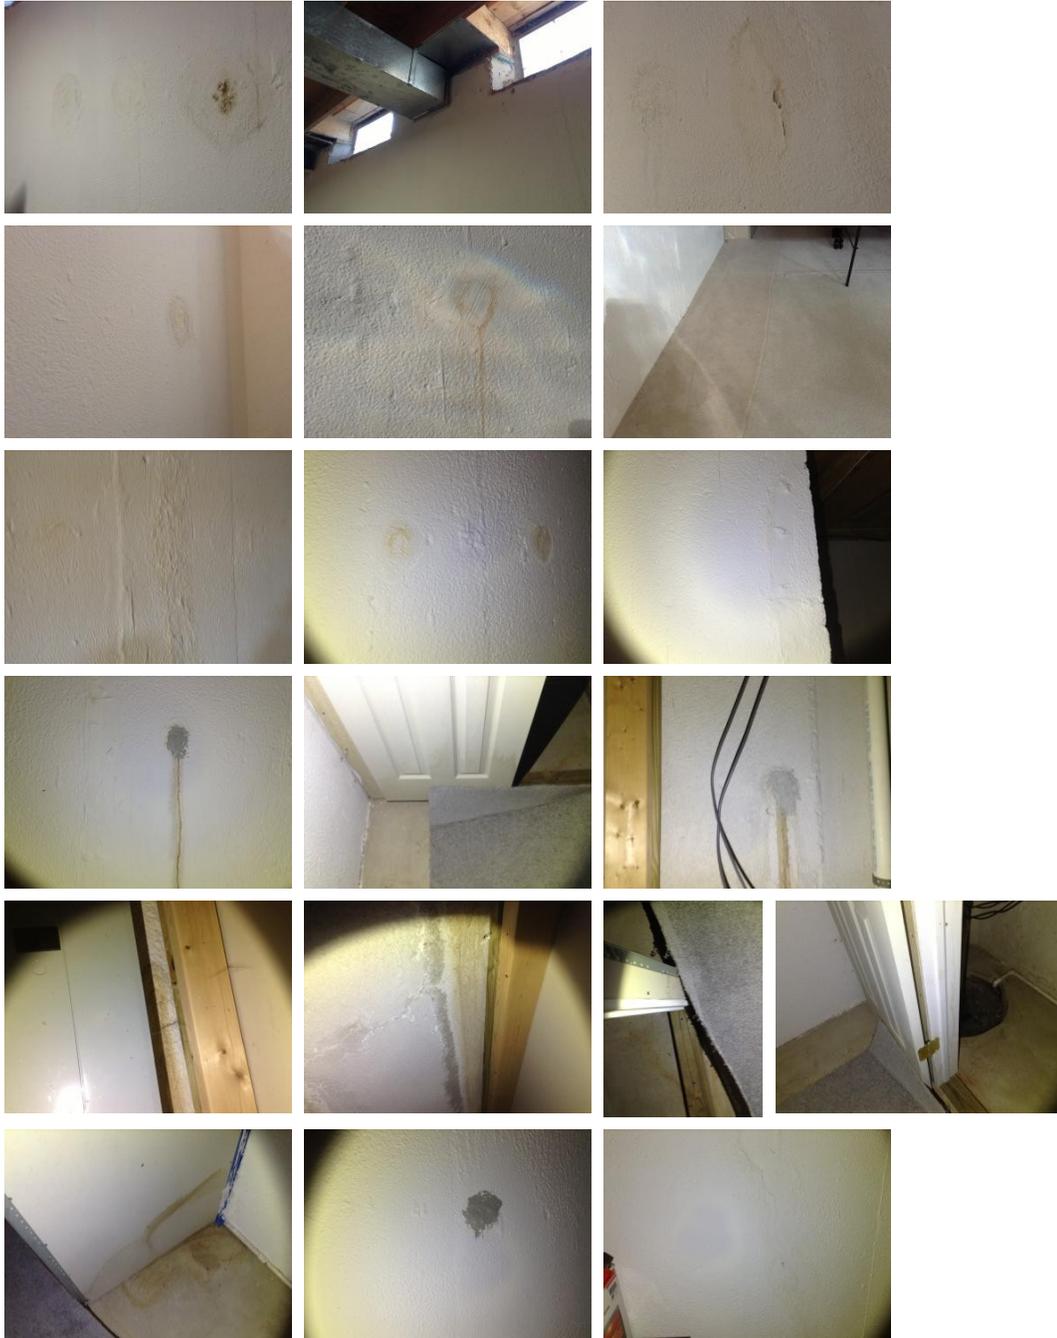
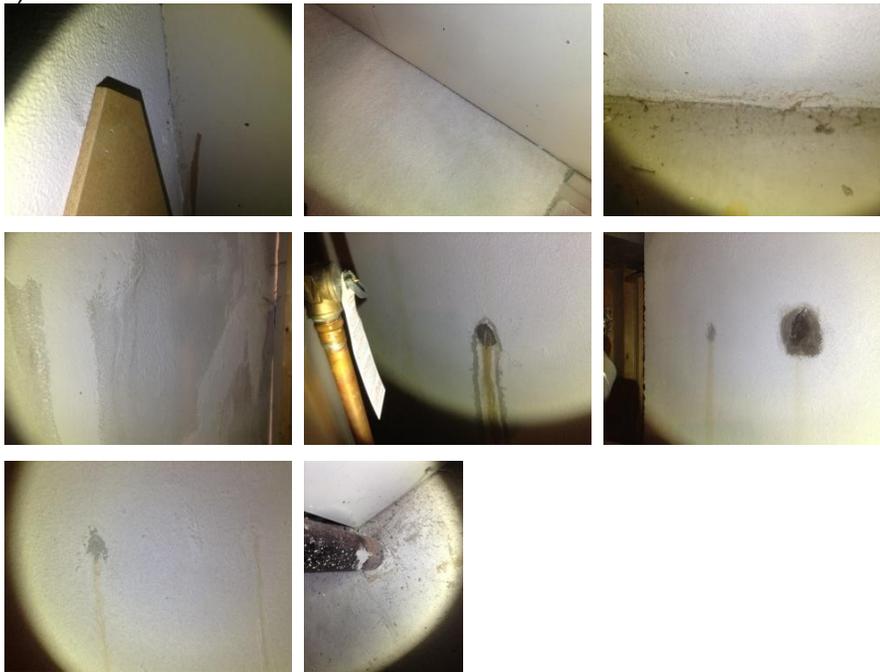
Defective

Overview: Evidence of water intrusion expect future problems, Expect water in basement due to poor exterior water control, Carpeting installed on the floor may provide a food source for mold, Efflorescence noted suggesting water leakage, Glass block windows restrict safe second egress out of basement, Patching noted at rod holes and cracks, Monitor rod holes for leaks and repair as needed, Monitor cracks for leaks and repair as needed, Water stain streaks running down the walls suggesting exterior siding water infiltration issues, Have the basement further evaluated to determine scope of work and cost to correct problems

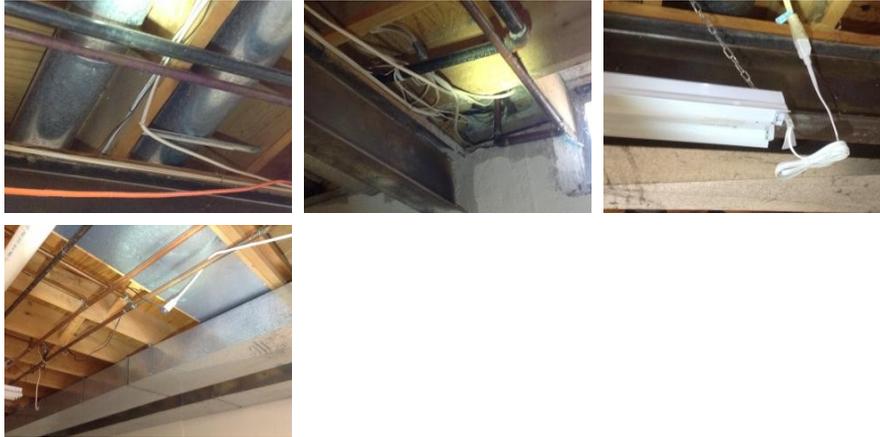
Marginal

Overview: Amateur wiring, Loose wiring, Improperly secured wiring, Wiring running under joists, Monitor and repair as needed

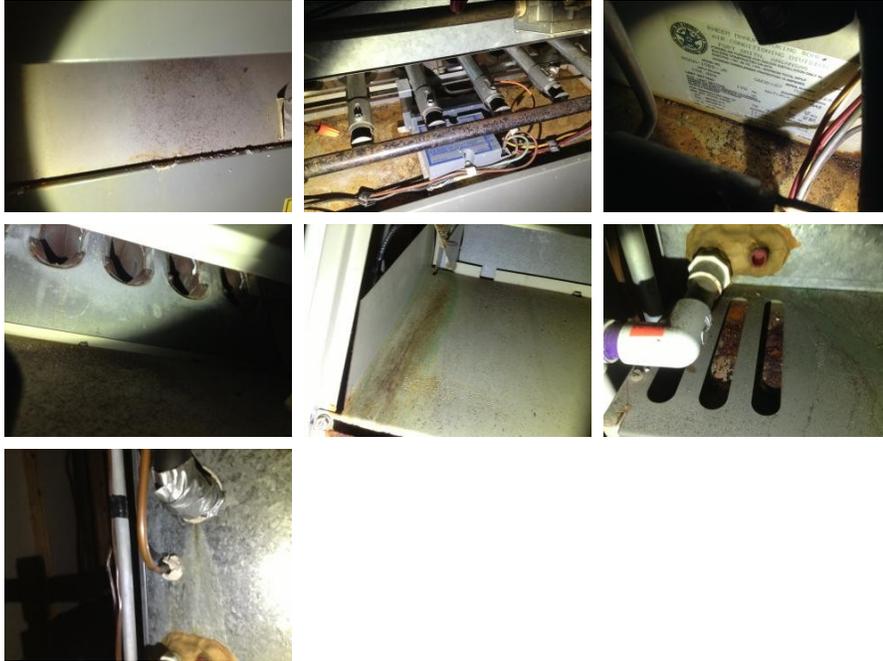
Heat Exchanger: Not fully visible for inspection Excessive rust, Recommend inspection by a qualified heating specialist

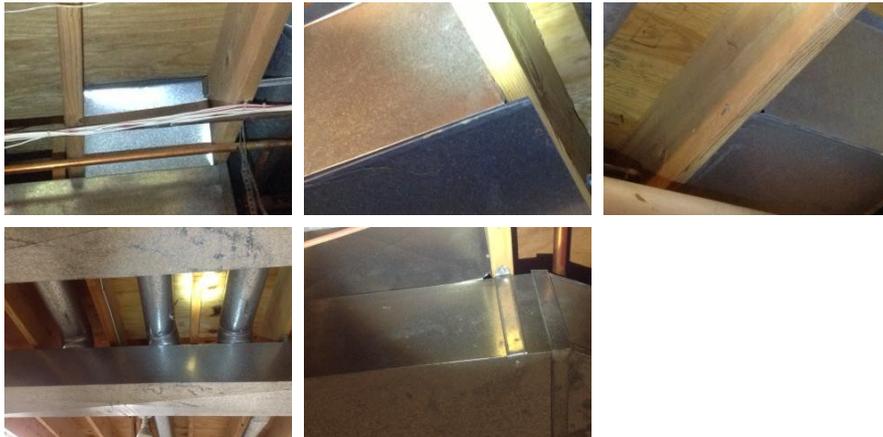
Marginal

Distribution: Metal duct Not balanced, Openings in ducts that reduce the efficiency of distribution, Monitor and repair or replace as needed

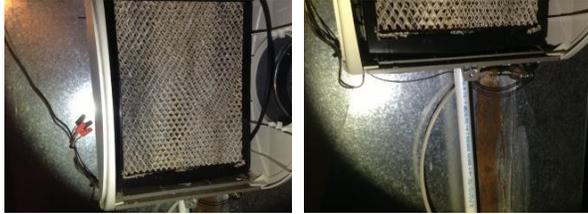
Defective

Humidifier: Flow-through Needs cleaning, Calcification observed, Evidence suggesting past leaks, Older unit expect to replace, A qualified contractor is recommended to evaluate and estimate repairs

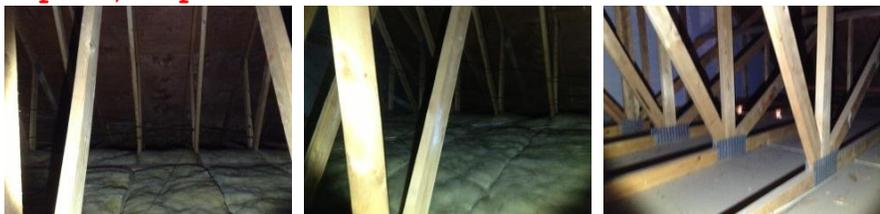
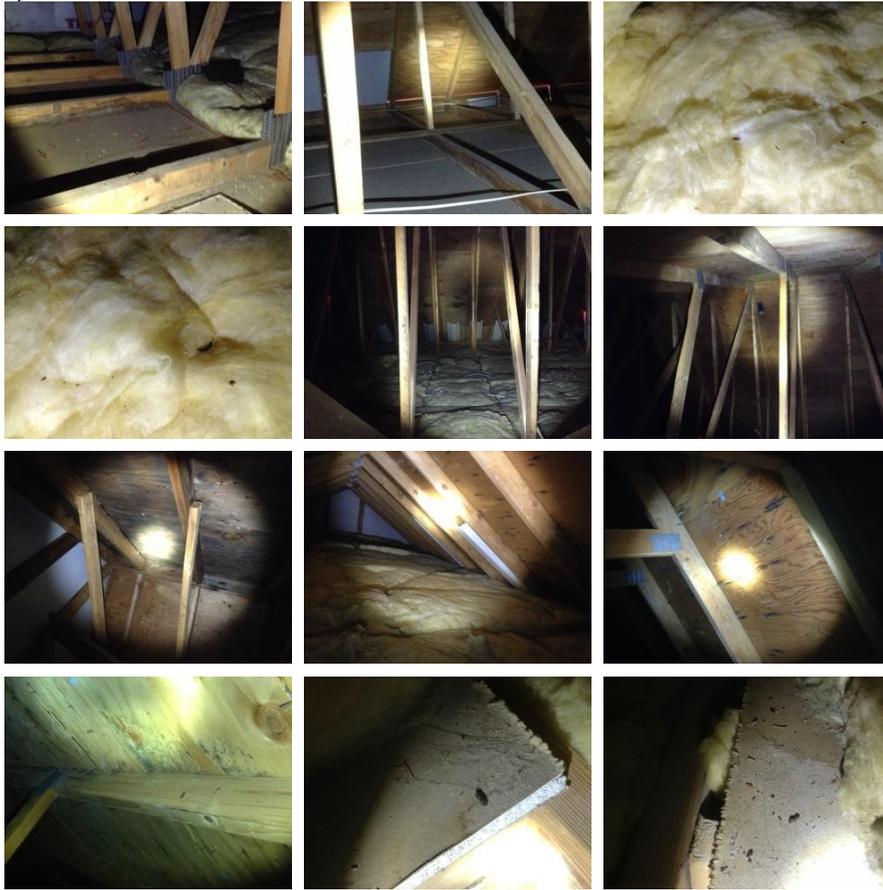
Defective

Overview: Poor ventilation, Evidence suggesting rodent activity, Evidence of moisture stains at the nail tips suggesting past over humidification, Observations made and relate to the accessible areas only, Have the attic further evaluated by a qualified contractor for repair, replacement and cost

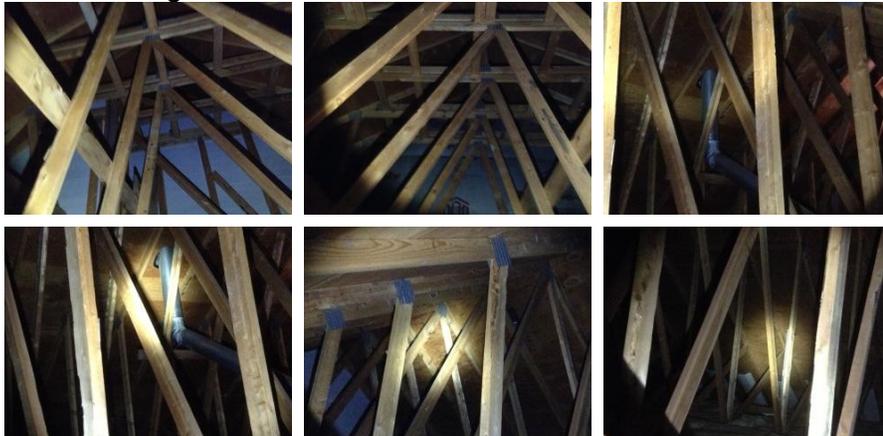
Sheathing: Plywood Water stains present, Discoloring due to moisture, Mold noted, Evidence suggesting over humidification and moisture stains at the nail tips, Have mold and mold mitigation needs evaluated by a qualified mold mitigator, indoor air quality testing by a third party is advised before mitigation begins and once mitigation is completed to validate mitigation was successful

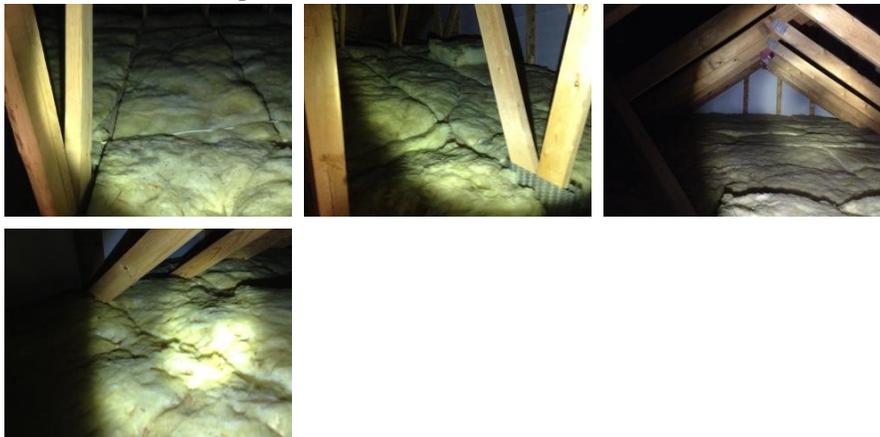
Marginal

Insulation: Fiberglass Recommend additional insulation be installed

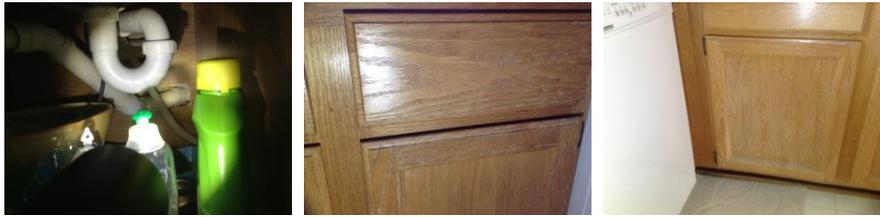
Marginal Counters/ Cabinets: **Older worn cabinets, Monitor and repair or replace as needed**

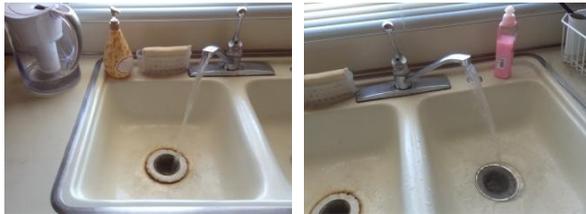
Marginal Plumbing/Fixtures: **Amateur drain line installation, Improper drain slope under sink, Monitor and repair as needed**

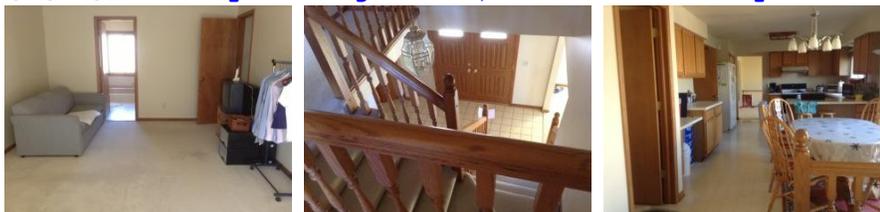
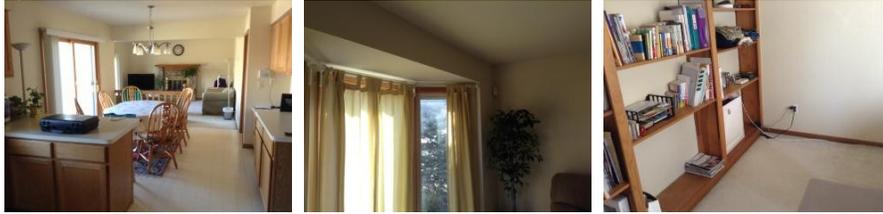
Marginal Overview: **Some patching noted, Monitor and repair as needed**

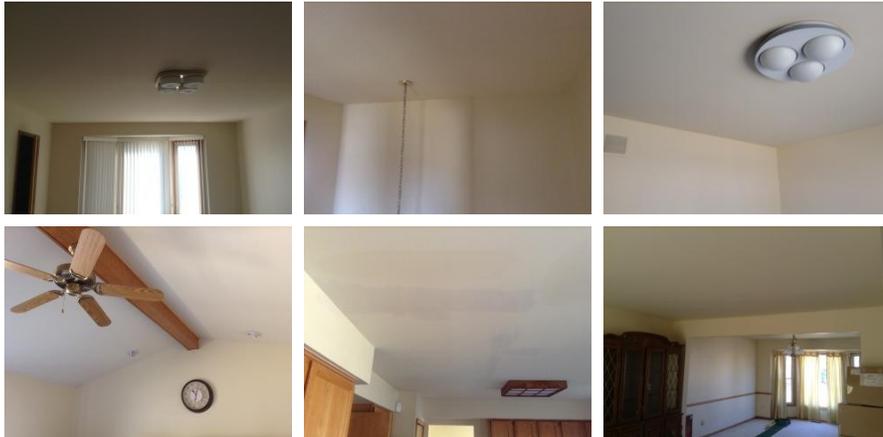
Marginal

Ceiling: Drywall Patched areas, Cracking, Nail pops, Areas suggesting past water damage, Recommend a qualified contractor further evaluate for repair, replacement and cost

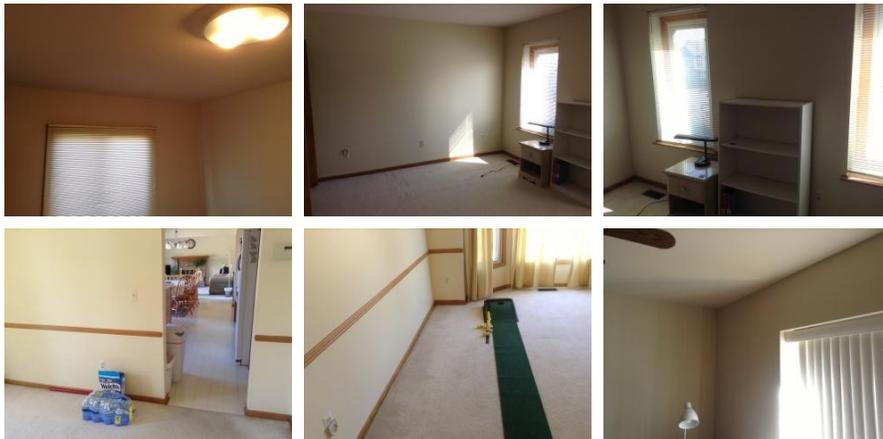
Marginal

Walls: Drywall Cracking, Nail pops, Areas suggesting past leakage, Monitor and correct as needed

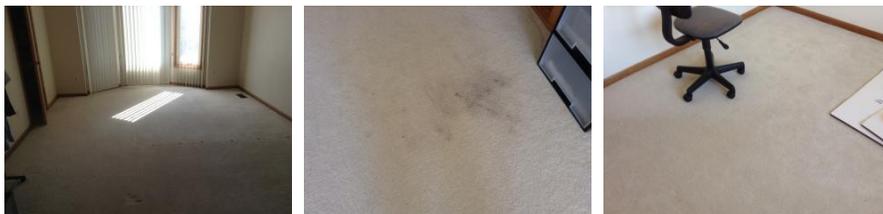
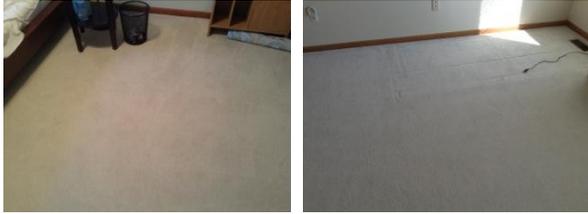
Marginal

Floors: Typical for age Carpet Stained/soiled, Monitor and correct as needed

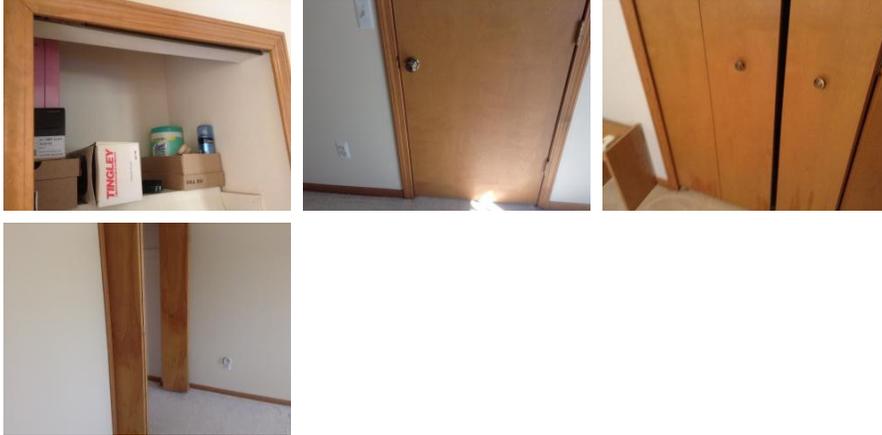
Marginal

Doors: Wood Missing some, Loose hardware

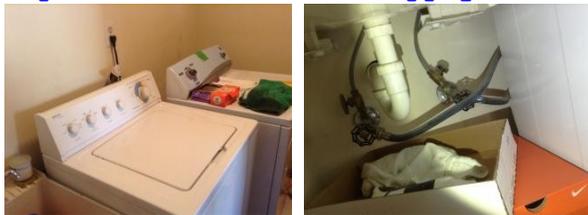
Marginal

Overview: Metal flex vent hose is a fire hazard replace for safety, Replace rubber water supply hoses with metal braided hoses

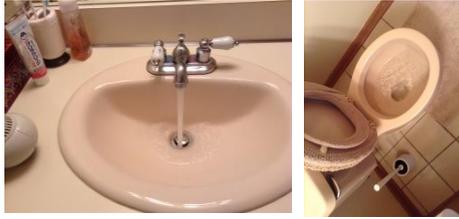
Defective

Plumbing/Fixtures: Toilet handle has to be held down to properly flush, Have a qualified contractor further evaluate and repair as needed

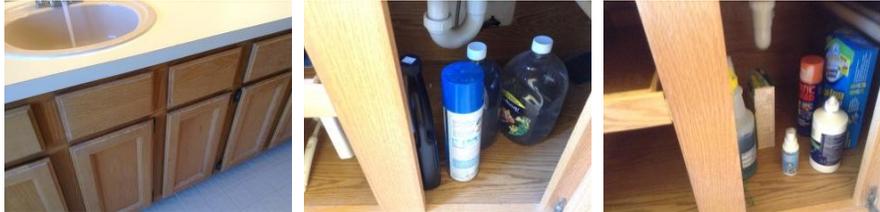
Overview:
Electrical:
Counters/ Cabinets: Older worn cabinets, Monitor and repair or replace as needed

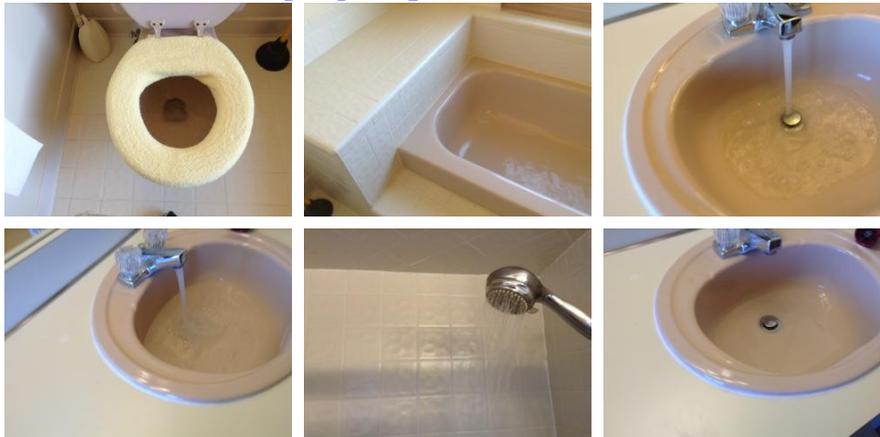
Marginal

Plumbing/Fixtures: Slow sink drain, Slow tub drain, Toilet handle has to be held down to properly flush, Monitor and correct as needed

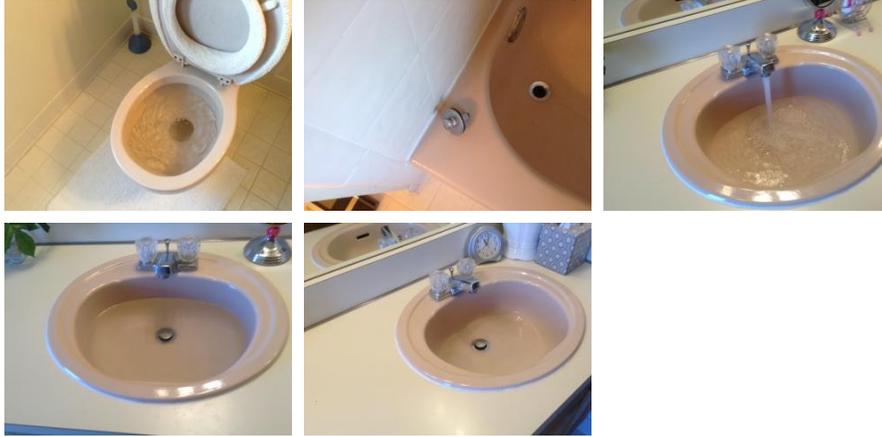
Defective

Plumbing/Fixtures: Toilet runs on, Disconnected drain stop at tub, Slow sink drains, Have a qualified contractor further evaluate and repair as needed
